11. Case Study

Post-Tropical Cyclone Gita Mission in Tonga

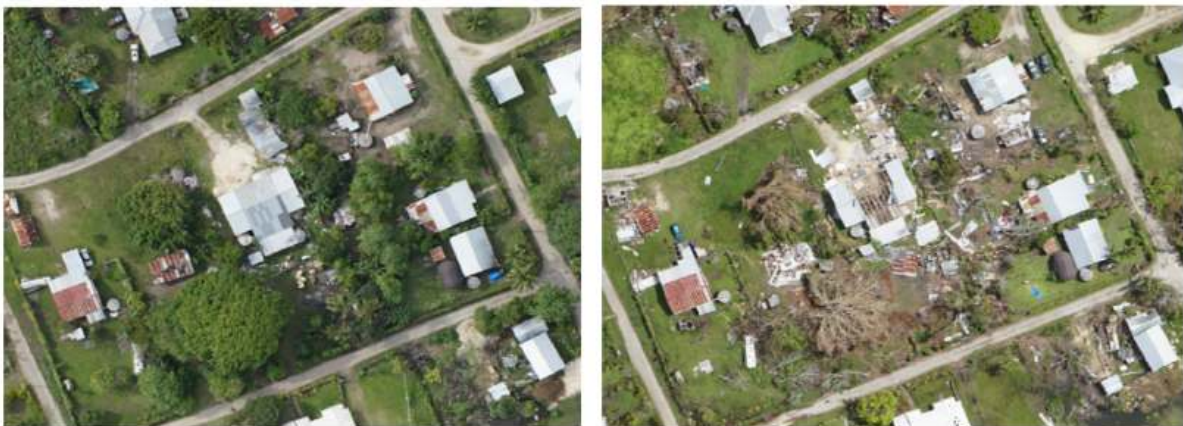
Figure 15 Images showing pre- and post-event status of the same structures.

Moreover, the collection of baseline data only a few months before Tropical Cyclone Gita hit Tonga proved to be invaluable. It not only provided usable data for post-disaster comparison, thus facilitating accurate damage assessments; it also acted as a trial run for the actual disaster, thus enabling the development of procedures, location of suitable flight areas, and rectification of problems. Figure 15_ shows an example of the same structure before and after the Cyclone.

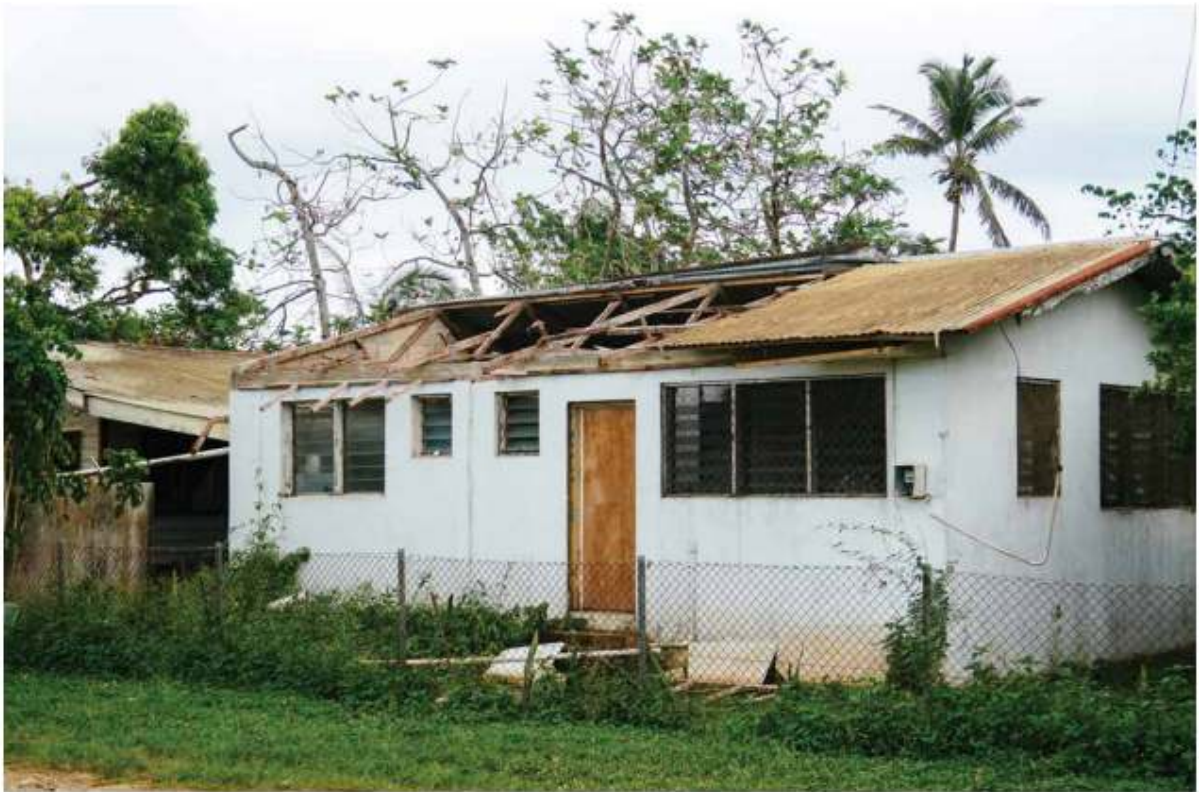
Figure 16 A house destroyed by Tropical Cyclone Gita in Longolongo village, Tongatapu, Tonga.

Photo: Malani Wolfgramm/World Bank. Damaged home in Longolongo, Tongatapu.

- *Crowdsourced building damage assessment by the Humanitarian OpenStreetMap Team (HOT).* The pre- and post-event UAV images were used to carry out a crowdsourced damage assessment. A small subset of volunteers from HOT were tasked with doing the visual interpretation of the damage to housing. A simple classification scheme was used: houses that appeared to be more than 50 percent damaged were labeled “destroyed,” and those that appeared to be less than 50 percent damaged were labeled “damaged” (Figure 16).
